THE STREAMBANK EROSION CONTROL
EVALUATION AND DEMONSTRATION ACT OF 1974
SECTION 32, PUBLIC LAW 93-251

Appendix G - Demonstration Projects on Other Streams, Nationwide
Volume 1 of 2

FINAL REPORT TO CONGRESS

APPENDIX G DEMONSTRATION PROJECTS ON OTHER STREAMS, NATIONWIDE

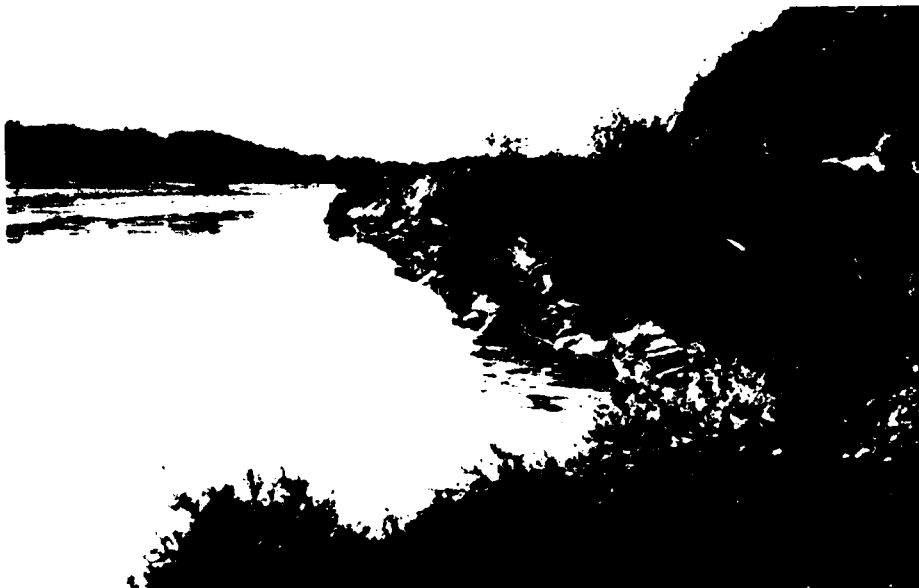
• The site plan of the River Road project area is shown on plate 14. Photos 1 through 3 show the project area and erosion bankline. At the side channel offtake, the bed is gravel and the velocity is approximately 6 feet per second, even at low flow. The side channel accounts for approximately 5 percent of the river flow. At the upstream end, the top of the bank is 8.5 feet above a water surface elevation representing 10,000 cubic feet per second. This area is considered a high flood plain and is covered with a new layer of sediment. According to geomorphic studies, the river was into the present flood plain area in 1938. The area also has a considerable number of trees which are less than 50 years old. The low flood plain is approximately 2 feet lower than the high flood plain. Up to 6 inches of new sediment have been deposited on the low flood plain. Unlike the high flood plain, there are no trees in the low flood plain area.

PHOTO 2. Northeastern View of Erosion Bankline.
A County Road and State Irrigation Pipe-
line Parallel This Bankline (Photo Taken
July 1979)

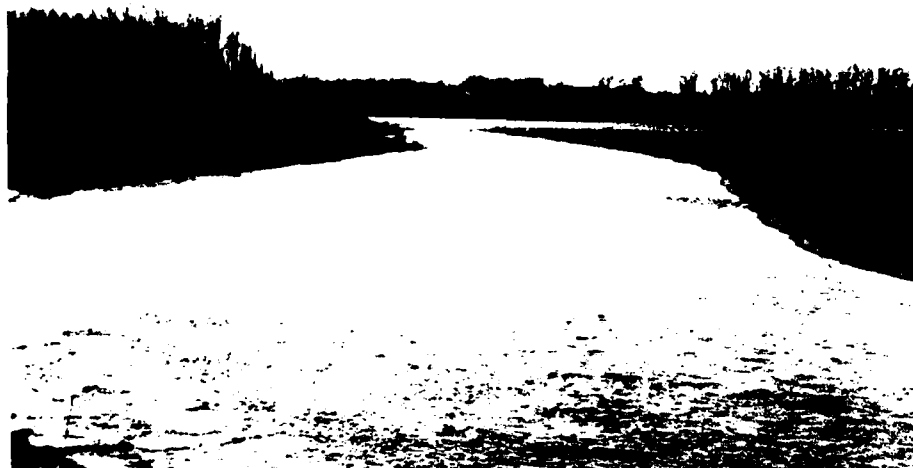
PHOTO 3. West View of Project Site at Side Channel
Prior to Construction. Alignment of the
Sand-Fill Dike Crosses the Side Channel at
Center of Photo (Photo Taken 2 November 1980)

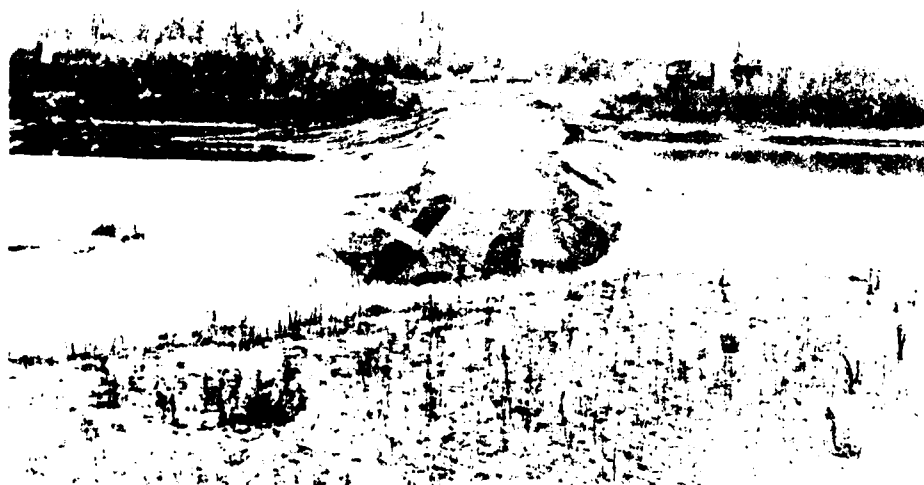
PHOTO 5. Closure Structure Completed
(Photo Taken 7 November 1980)

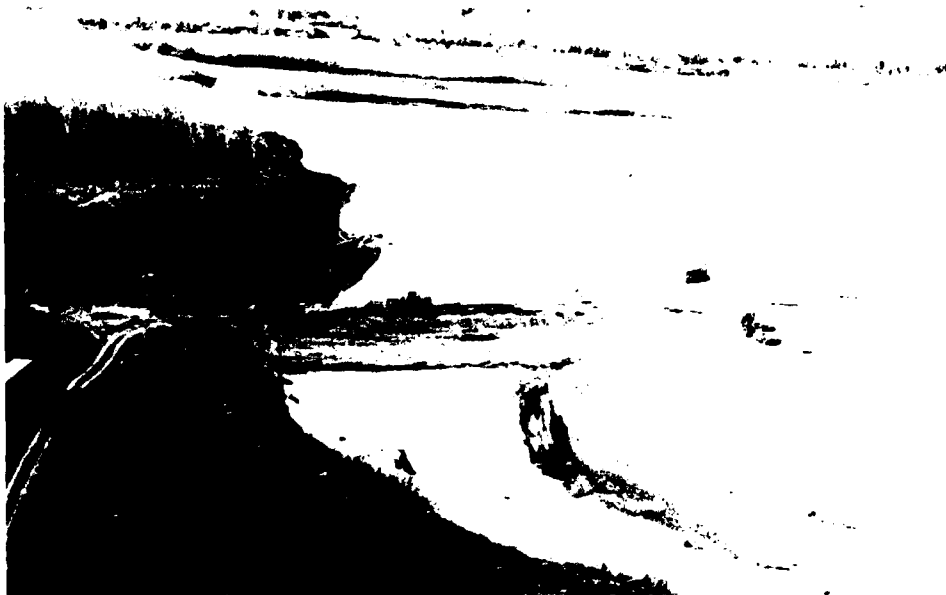
PHOTO 6. Construction Operations Showing Placement of Sand-Fill on Dike (Photo Taken 8 November 1980)

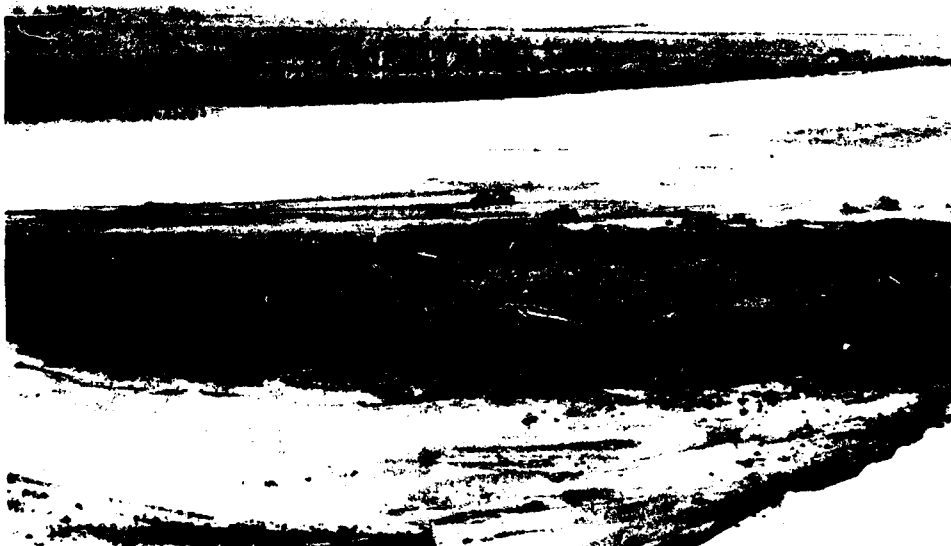
PHOTO 7. Borrow Operations of Island Looking Downstream from Hilltop (Photo Taken 11 November 1980)

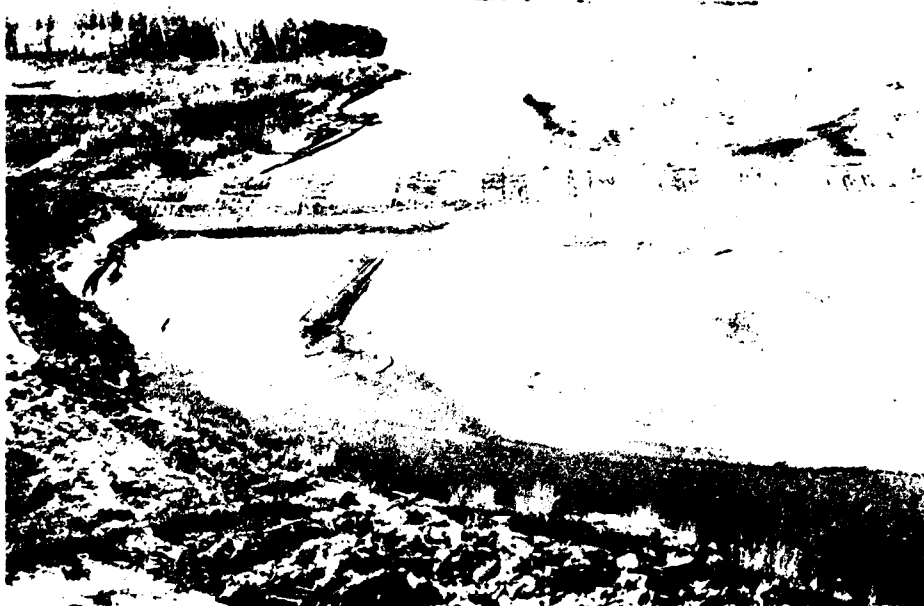
PHOTO 8. Completed Sand Fill Dike Showing Furrows Where Sprigs of Bullrushes are planted (Photo Taken 17 November 1980)

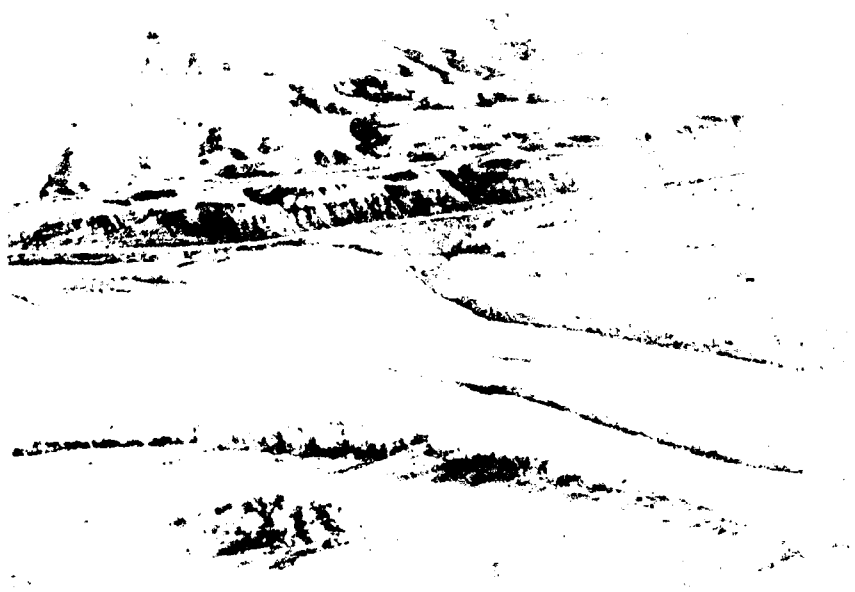
PHOTO 9. Southeastern Aerial View of Completed Sand-Fill Dike (Photo Taken 26 November 1980)

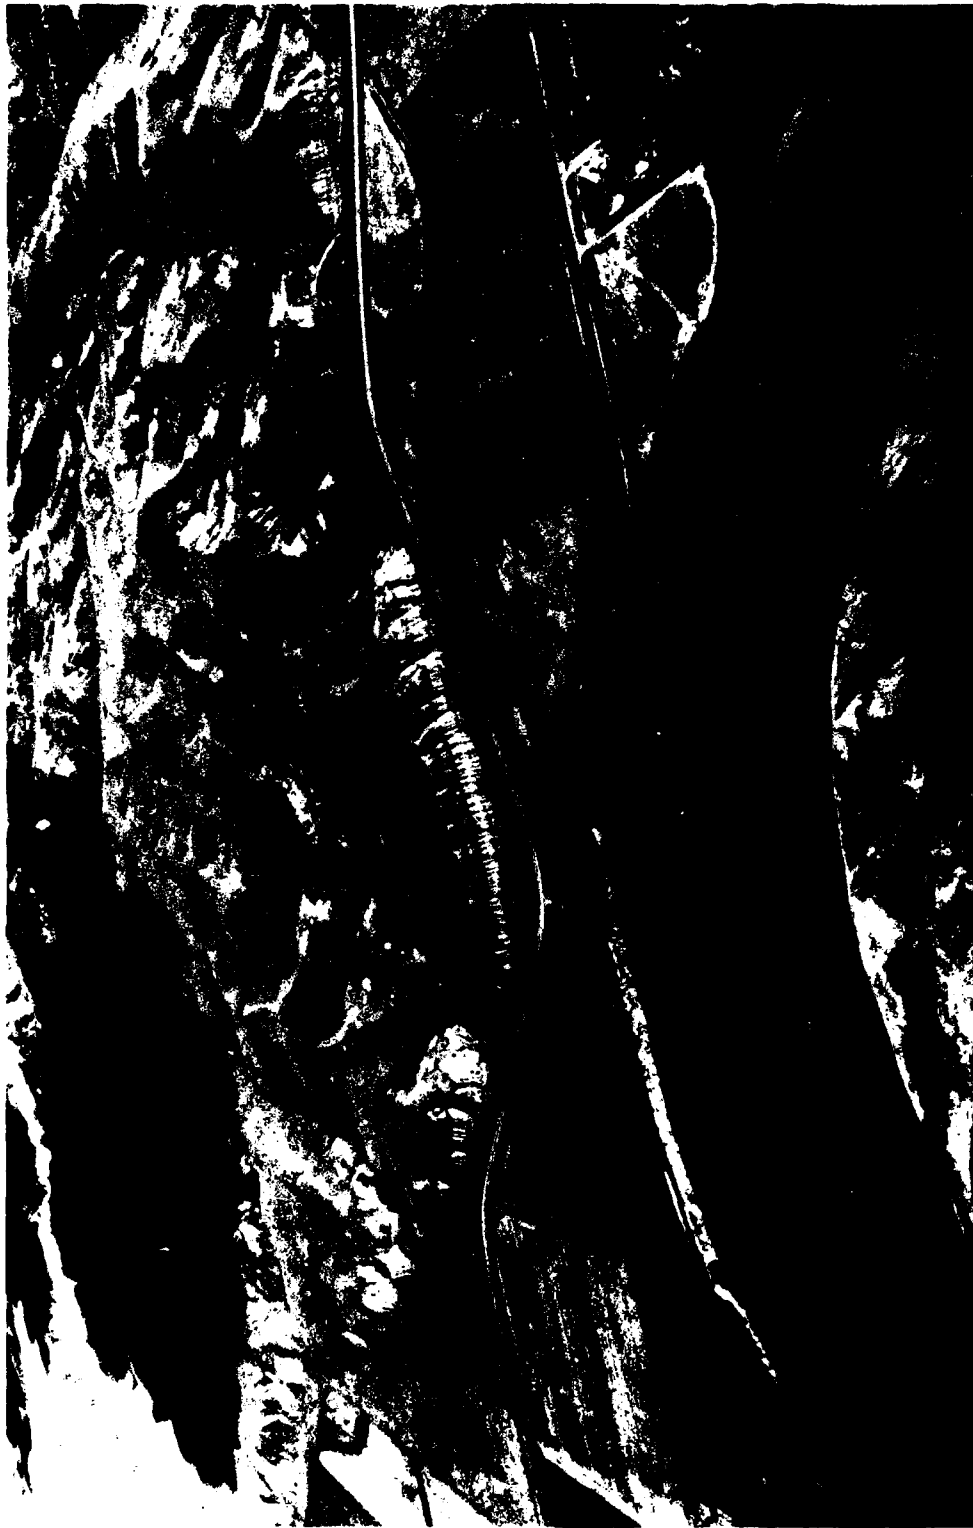
PHOTO 10

• Plate 16 shows the Cheney Creek area site plan. Photos 10 through 14 show the erosive bankline. The bankline at the structure location is a relatively low terrace approximately 19.5 feet above the water surface elevation representing 10,000 cubic feet per second. The terrace is cultivated but not irrigated. There is a 4-foot upper silt and clay layer that covers a 2-foot coarse sand layer on the upper bank. A deep fine sand layer slopes toward the river. The downstream bankline is an older terrace 25.5 feet high with vertical banks. There is a 6-inch to 18-inch clay layer covering the sand. The terrace is cultivated and irrigated.

PHOTO 10. Eastern Aerial View of Erosion Site Before Construction
(Photo Taken 22 November 1980)

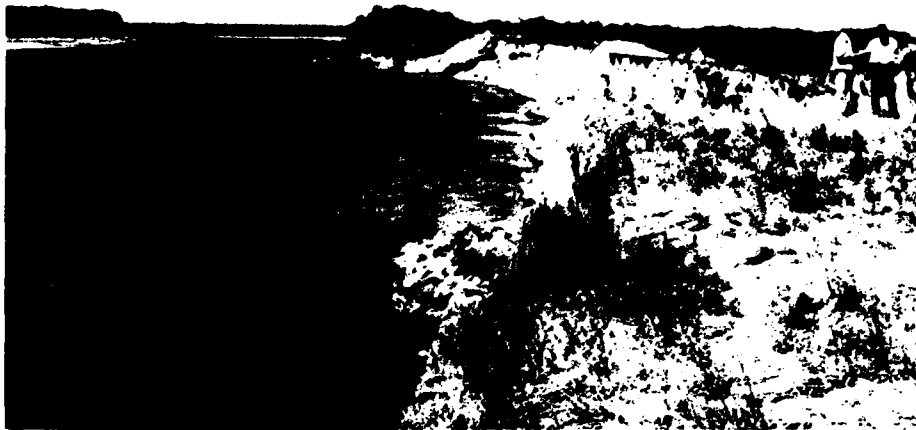
PHOTO 11. Erosion Site Prior to Construction
Looking Downstream From Mid-Point
(Photo Taken 6 August 1980)

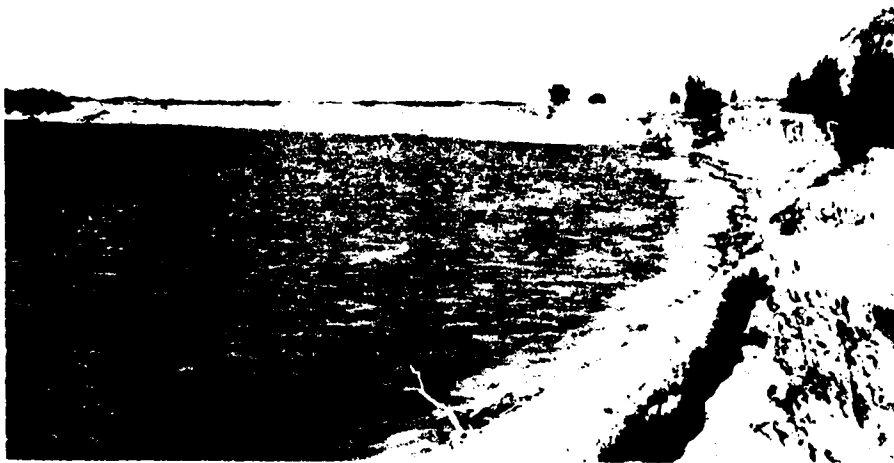
PHOTO 13. Erosion Site Prior to Construction Looking Downstream From Upstream End of Project (Photo Taken 6 August 1980)

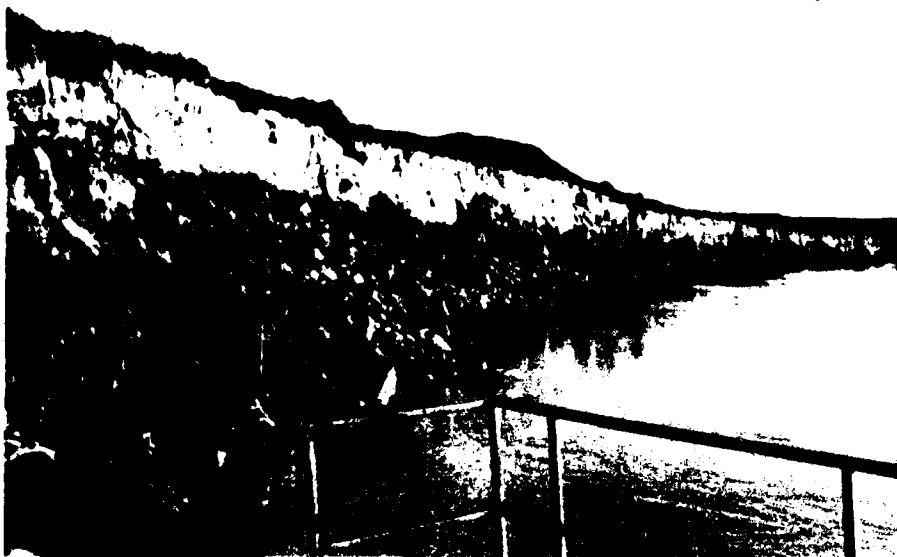
PHOTO 14. Erosion Site Prior to Construction Looking Upstream From Downstream End of Project at Portable Irrigation Intake Platform (Photo Taken 22 September 1980)

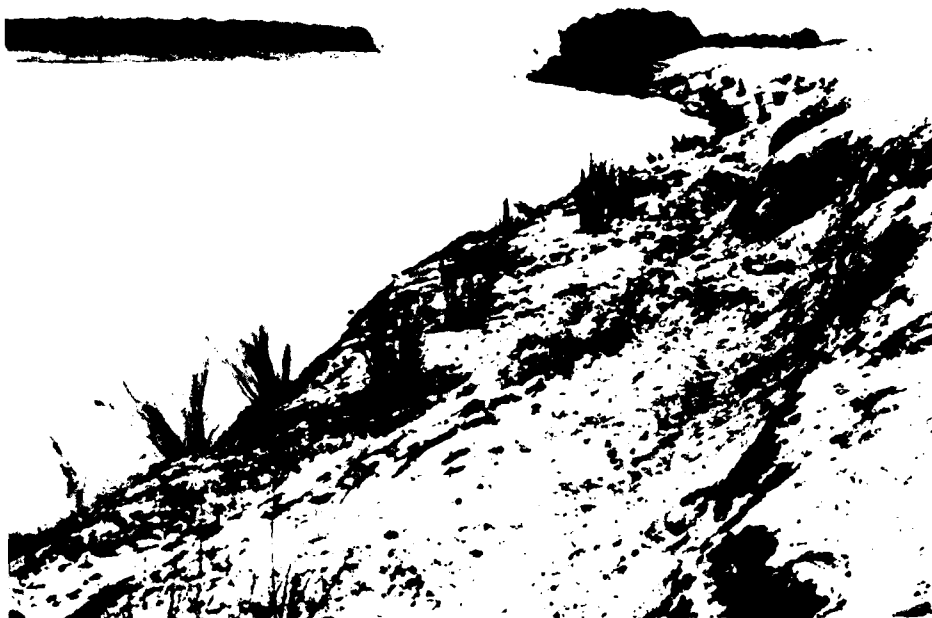
Soon after construction of the stone revetment and sloped upperbank backfill, a slump occurred along the central portion of Subreach C (the downstream half of the structure) for approximately 500 feet. See Photos 17 and 18. The fill material slid approximately 6 to 10 feet vertically at the landward edge, and slumped riverward over the stone revetment. The revetment alignment remained stationary. Precise cause of the failure is not known, but is probably caused by the 1 vertical to 2 horizontal slope with uncompacted fill as specified for Subreach C. It was determined that the area

PHOTO 17. Five Months After Construction Looking
Downstream From Near Mid-Point of Project
(Photo Taken 7 May 1981)

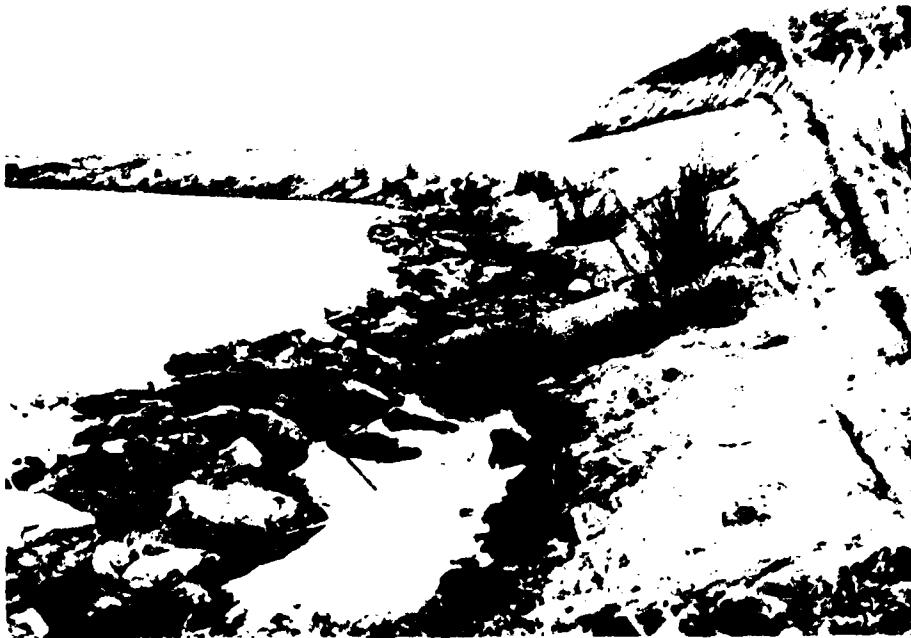
Photos 17 through 20 show the completed project. Photo 23 shows an aerial view of the project area and the completed structure.

PHOTO 19. After Construction Looking Downstream
From Upstream End of Project (Photo
Taken 7 May 1981)

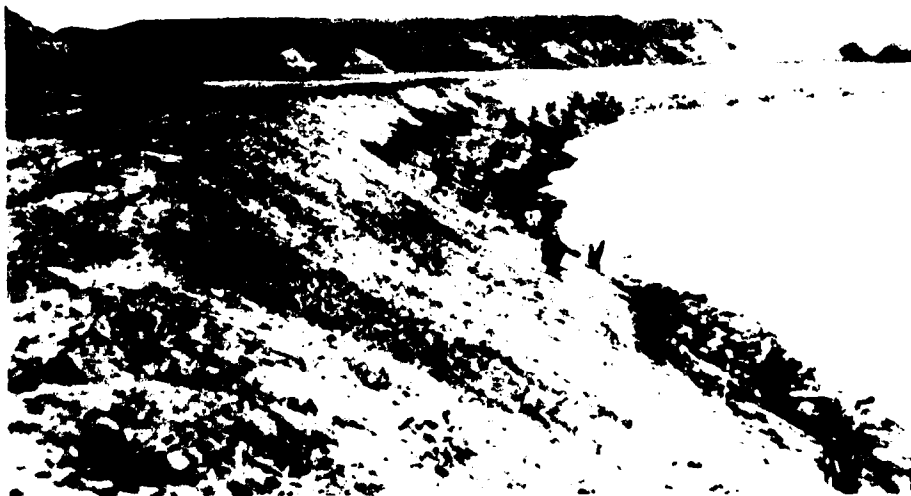
PHOTO 20. After Construction Looking Upstream
From Downstream End of Project (Photo
Taken 7 May 1981)

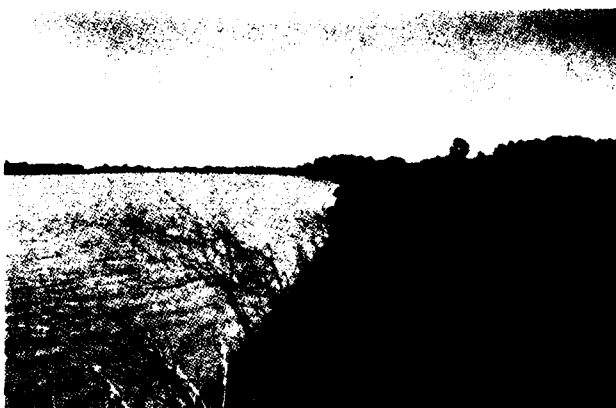
TIMBER PILE REACH

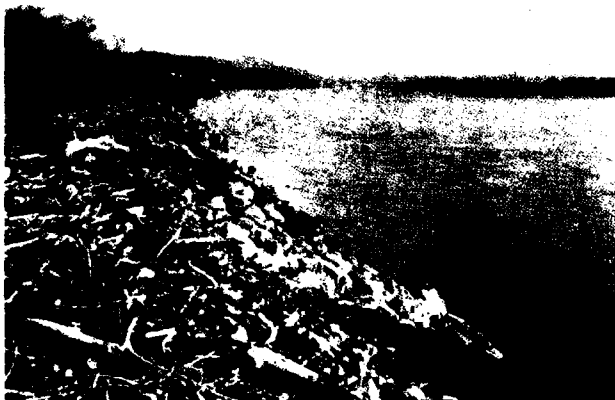
HARDPOINT REACH

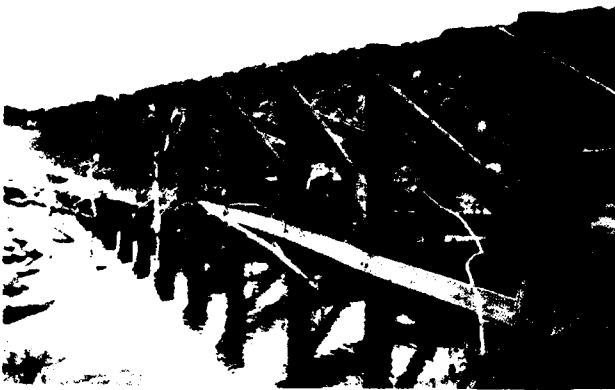
TIMBER PILE REACH

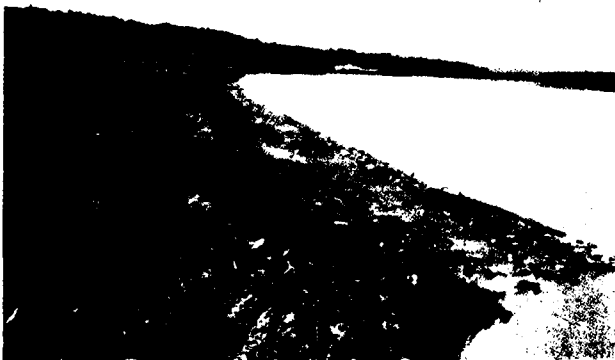
ROCK TOE REACH

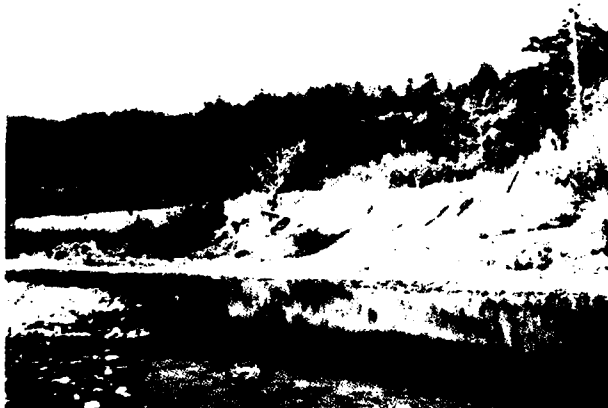
PROJECT SITE

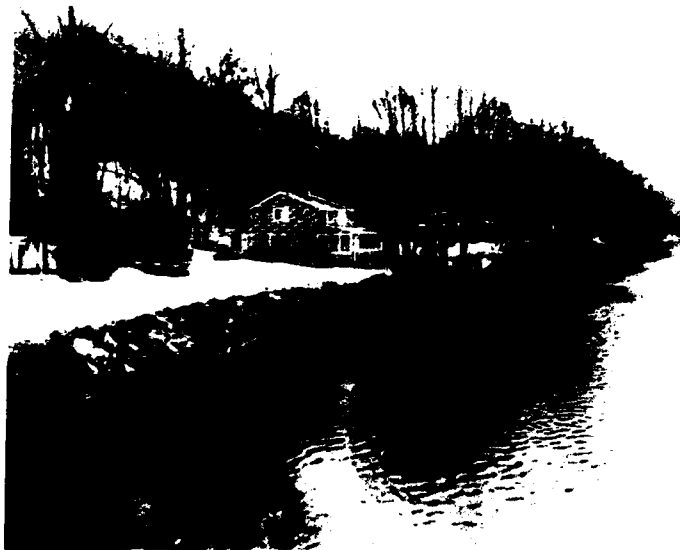
PLATE 16

Both Schemes 1A and 1B resisted the forces of ice and water with no signs of distress. There has been no apparent gouging, settlement, or loss of stone protection. Sequential photos of Scheme 1 are shown on Plates 16, 17, 18 and 19.

BEFORE CONSTRUCTION
FROM STATION 10+00
12 DECEMBER 1978

DURING CONSTRUCTION FROM
STATION 10+00
20 DECEMBER 1979

ALLEGHENY RIVER
WATTERSONVILLE, PA.
SCHEME 1A PHOTOS

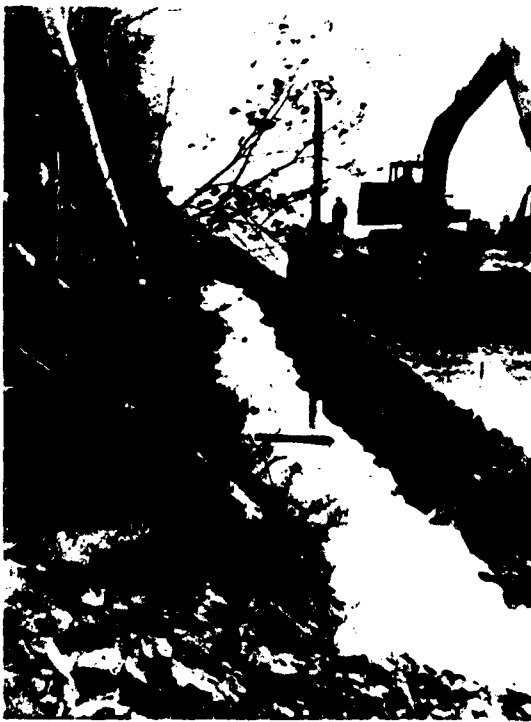
PLATE 20

The longitudinal stone dike is undamaged, however, the sand and gravel fill shows signs of gouging by ice and disturbance by high river flows. Plates 20 and 21 show photos of Scheme 2.

BEFORE CONSTRUCTION
FROM STATION 19+50
1 MAY 1979

DURING CONSTRUCTION
FROM STATION 19+50
15 NOVEMBER 1979

ALLEGHENY RIVER
WATTERSONVILLE, PA.
SCHEME 2 PHOTOS

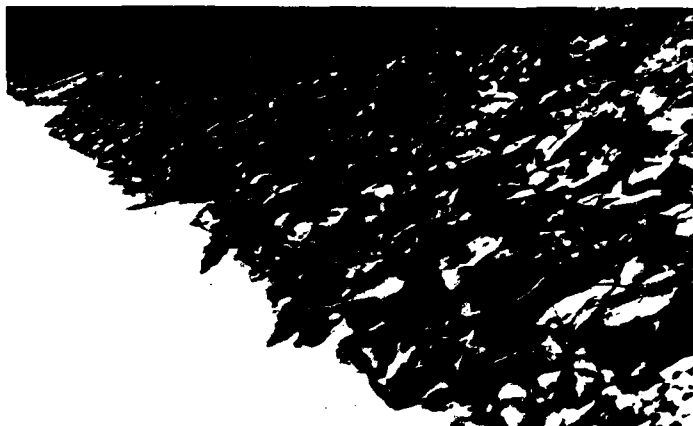
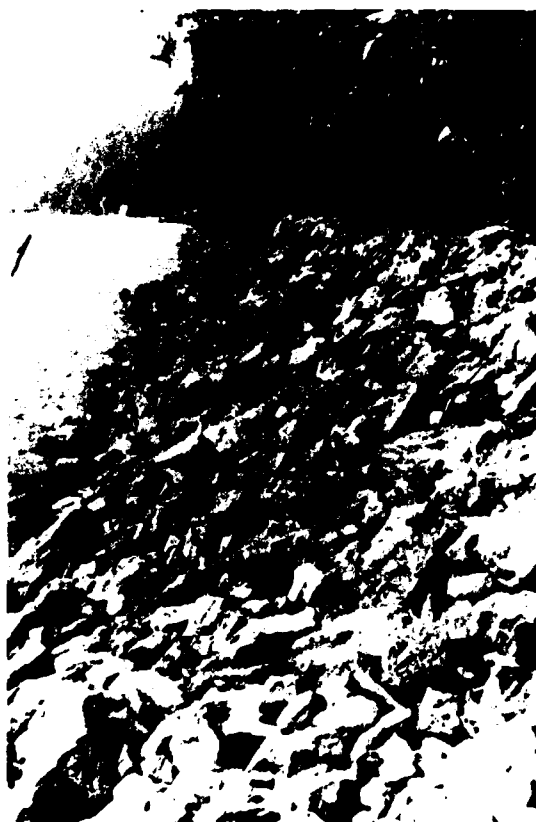
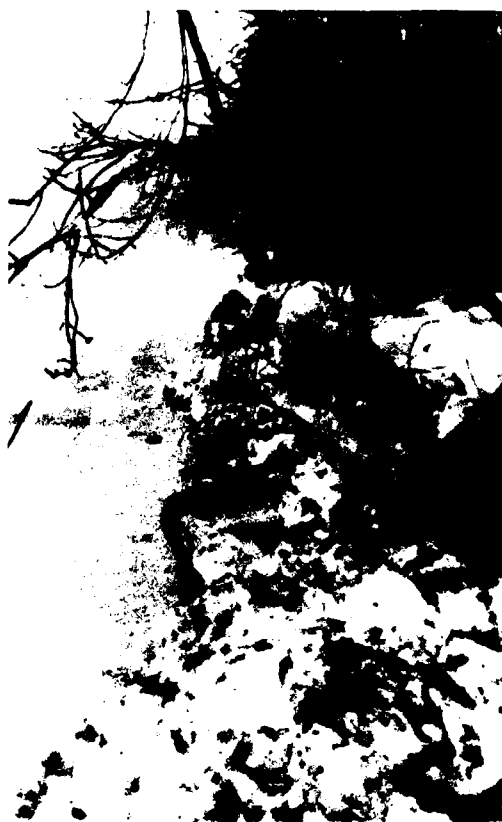
The stone fill placed against the bank face has remained intact with no signs of disturbance. Photos of Scheme 3 are shown on Plates 22 and 23.

RIVER FROZEN OVER
FROM STATION 24+00
12 FEBRUARY 1980

FROM STATION 24+00
27 JUNE 1980

STACKED ICE ALONG SHORE
FROM STATION 24+00
20 FEBRUARY 1981

ALLEGHENY RIVER
WATTERSONVILLE, PA.
SCHEME 3 PHOTOS

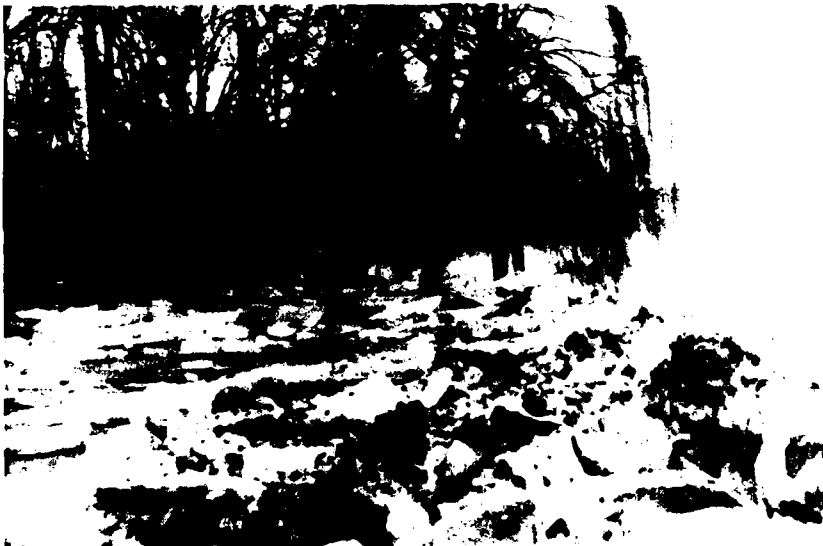
STACKED ICE ALONG RIVERBANK
FROM STATION 27+00
20 FEBRUARY 1981

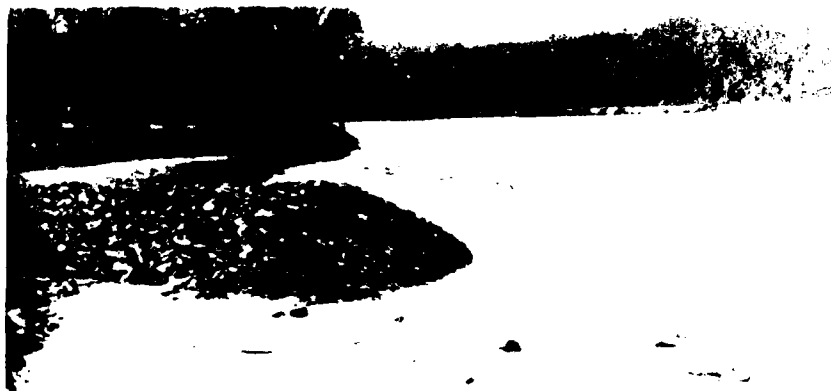
RIVER FROZEN OVER
VIEW FROM STATION 31+00
NOTE SHEARED ICE ZONE BEYOND NOSE OF HARDPOINT
12 FEBRUARY 1980

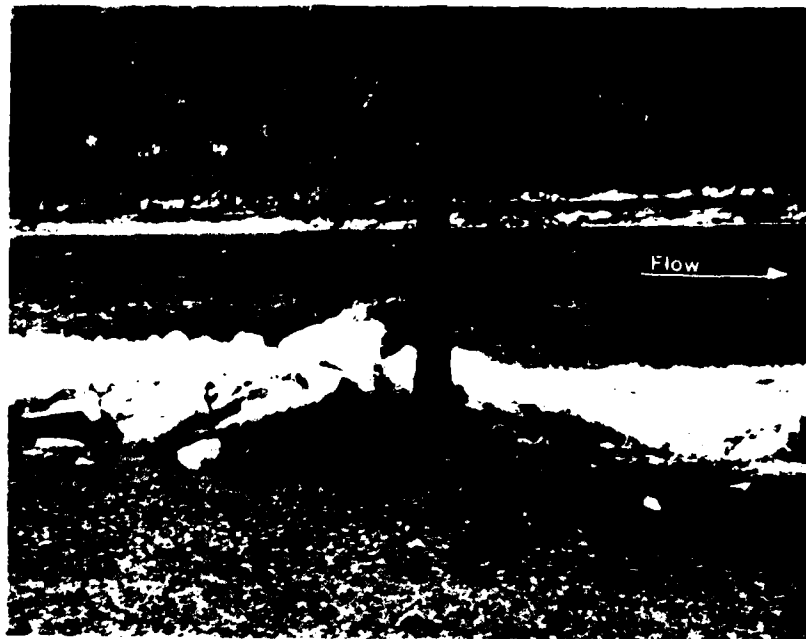
ICE FLOE GOUGING OF RIVER BANK
AT STATION 30+50
28 FEBRUARY 1977

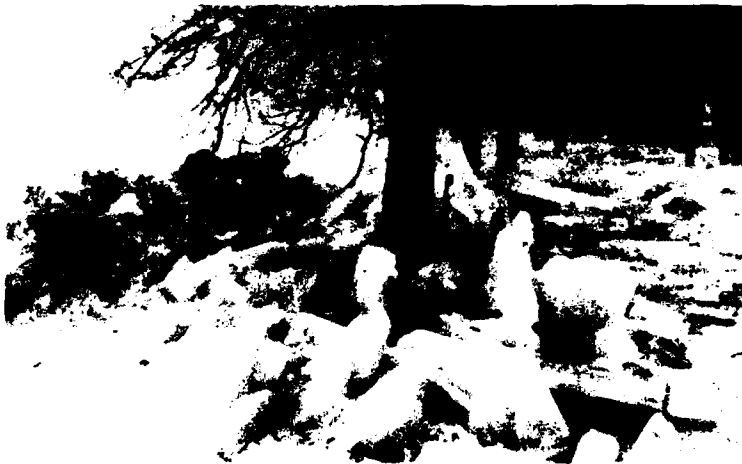
VIEW LOOKING
DOWNSTREAM OF
ICE OVERRIDING
HARDPOINT AT
STATION 30+00
20 FEBRUARY 1981

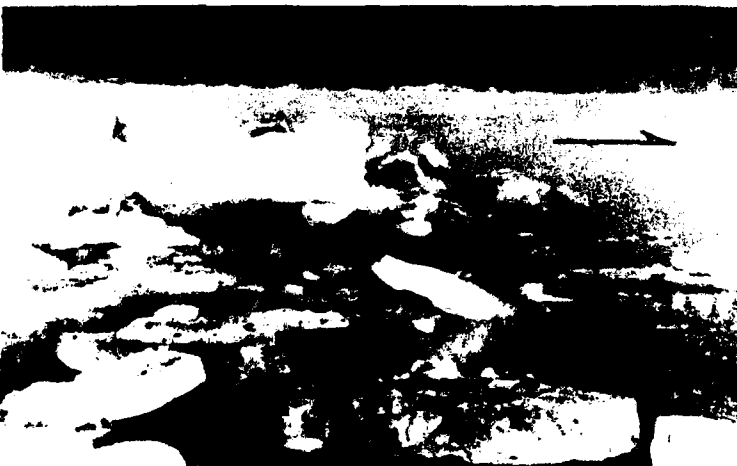
VIEW OF HARD-
POINT AT STATION
30+00, NOTE ICE
STACKED UPSTREAM
OF HARDPOINT AND
ABSENCE OF ICE
IMMEDIATELY DOWN-
STREAM OF HARD-
POINT
20 FEBRUARY 1981

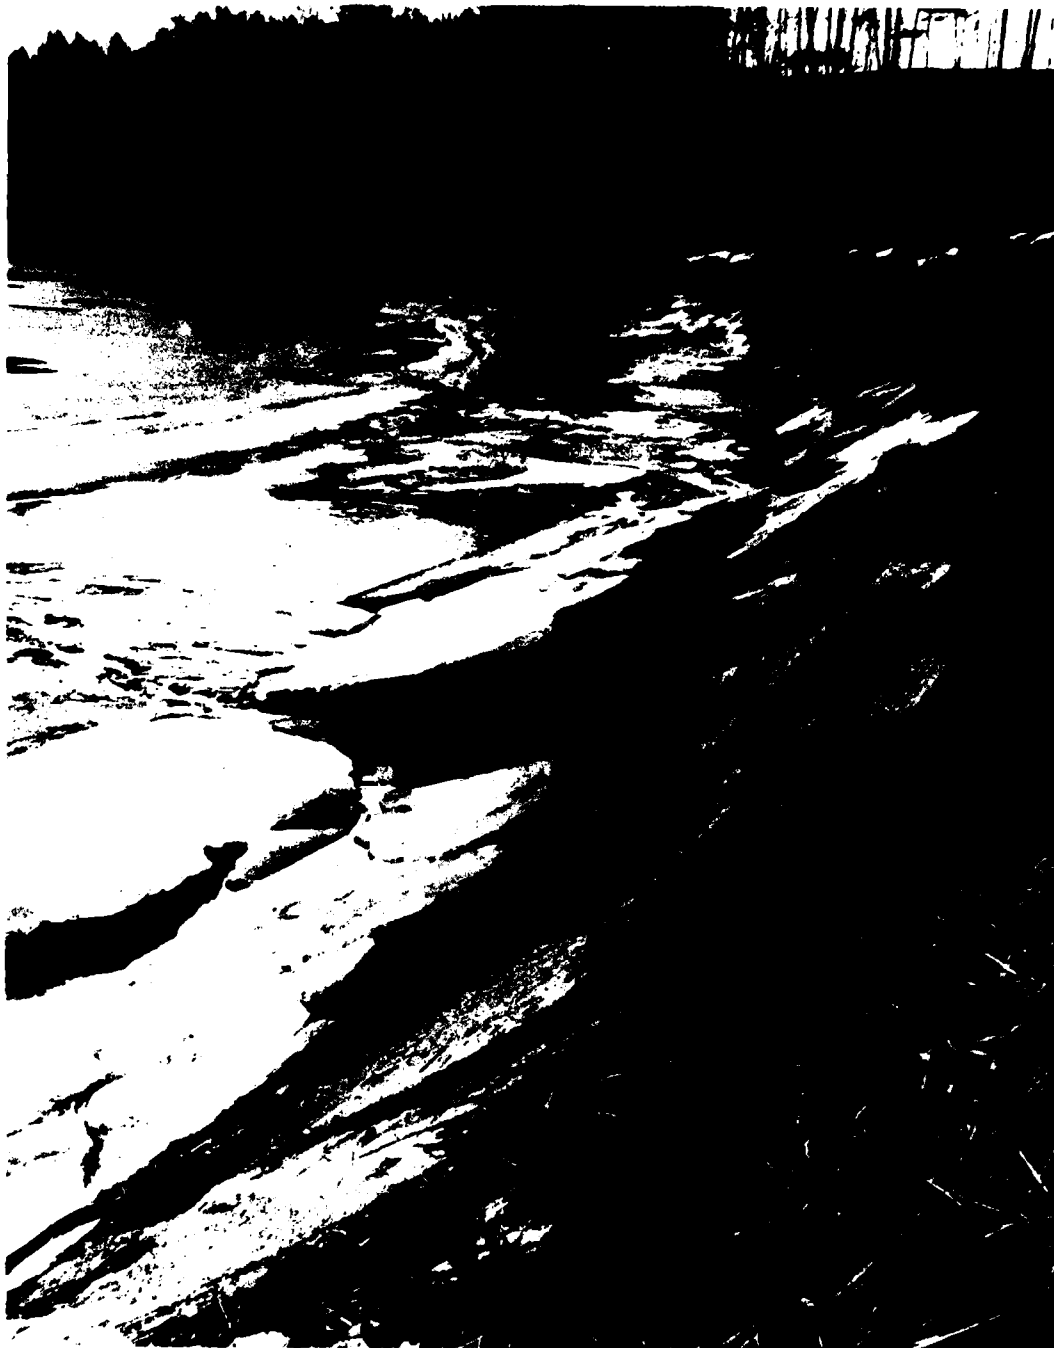
PHOTO 13

ICE CONDITIONS
20 FEBRUARY 1981
VIEW LOOKING UPSTREAM

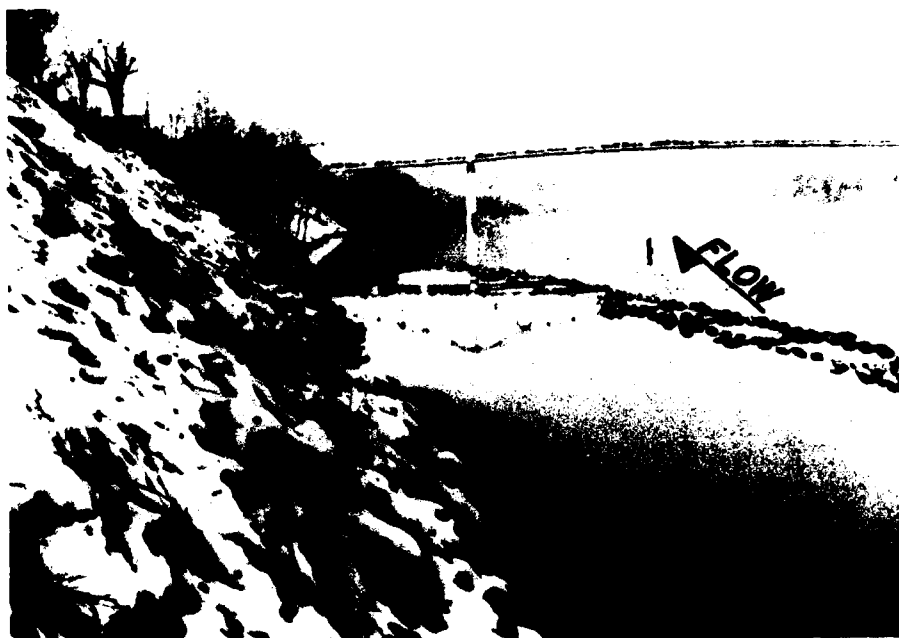
EXHIBIT 11-6

SCHEME C: LOOKING DOWNSTREAM AFTER CONSTRUCTION
